(NASA-CR-134130) ENGINEERING REPORT.
PART 3: NASA LIGHTWEIGHT WHEEL AND
BRAKE SUB-SYSTEM. LIGHTWEIGHT BRAKE
DEVELOPMENT (Goodrich (B. F.) Co.) 85 p
HC \$6.25 CSCL 22B G3/31 N74-12506
Unclas
22835

ENGINEERING REPORT NO. 4239
NASA LIGHTWEIGHT WHEEL AND BRAKE
SUB-SYSTEM CONTRACT WITH
B. F. GOODRICH

PART III
LIGHTWEIGHT BRAKE DEVELOPMENT

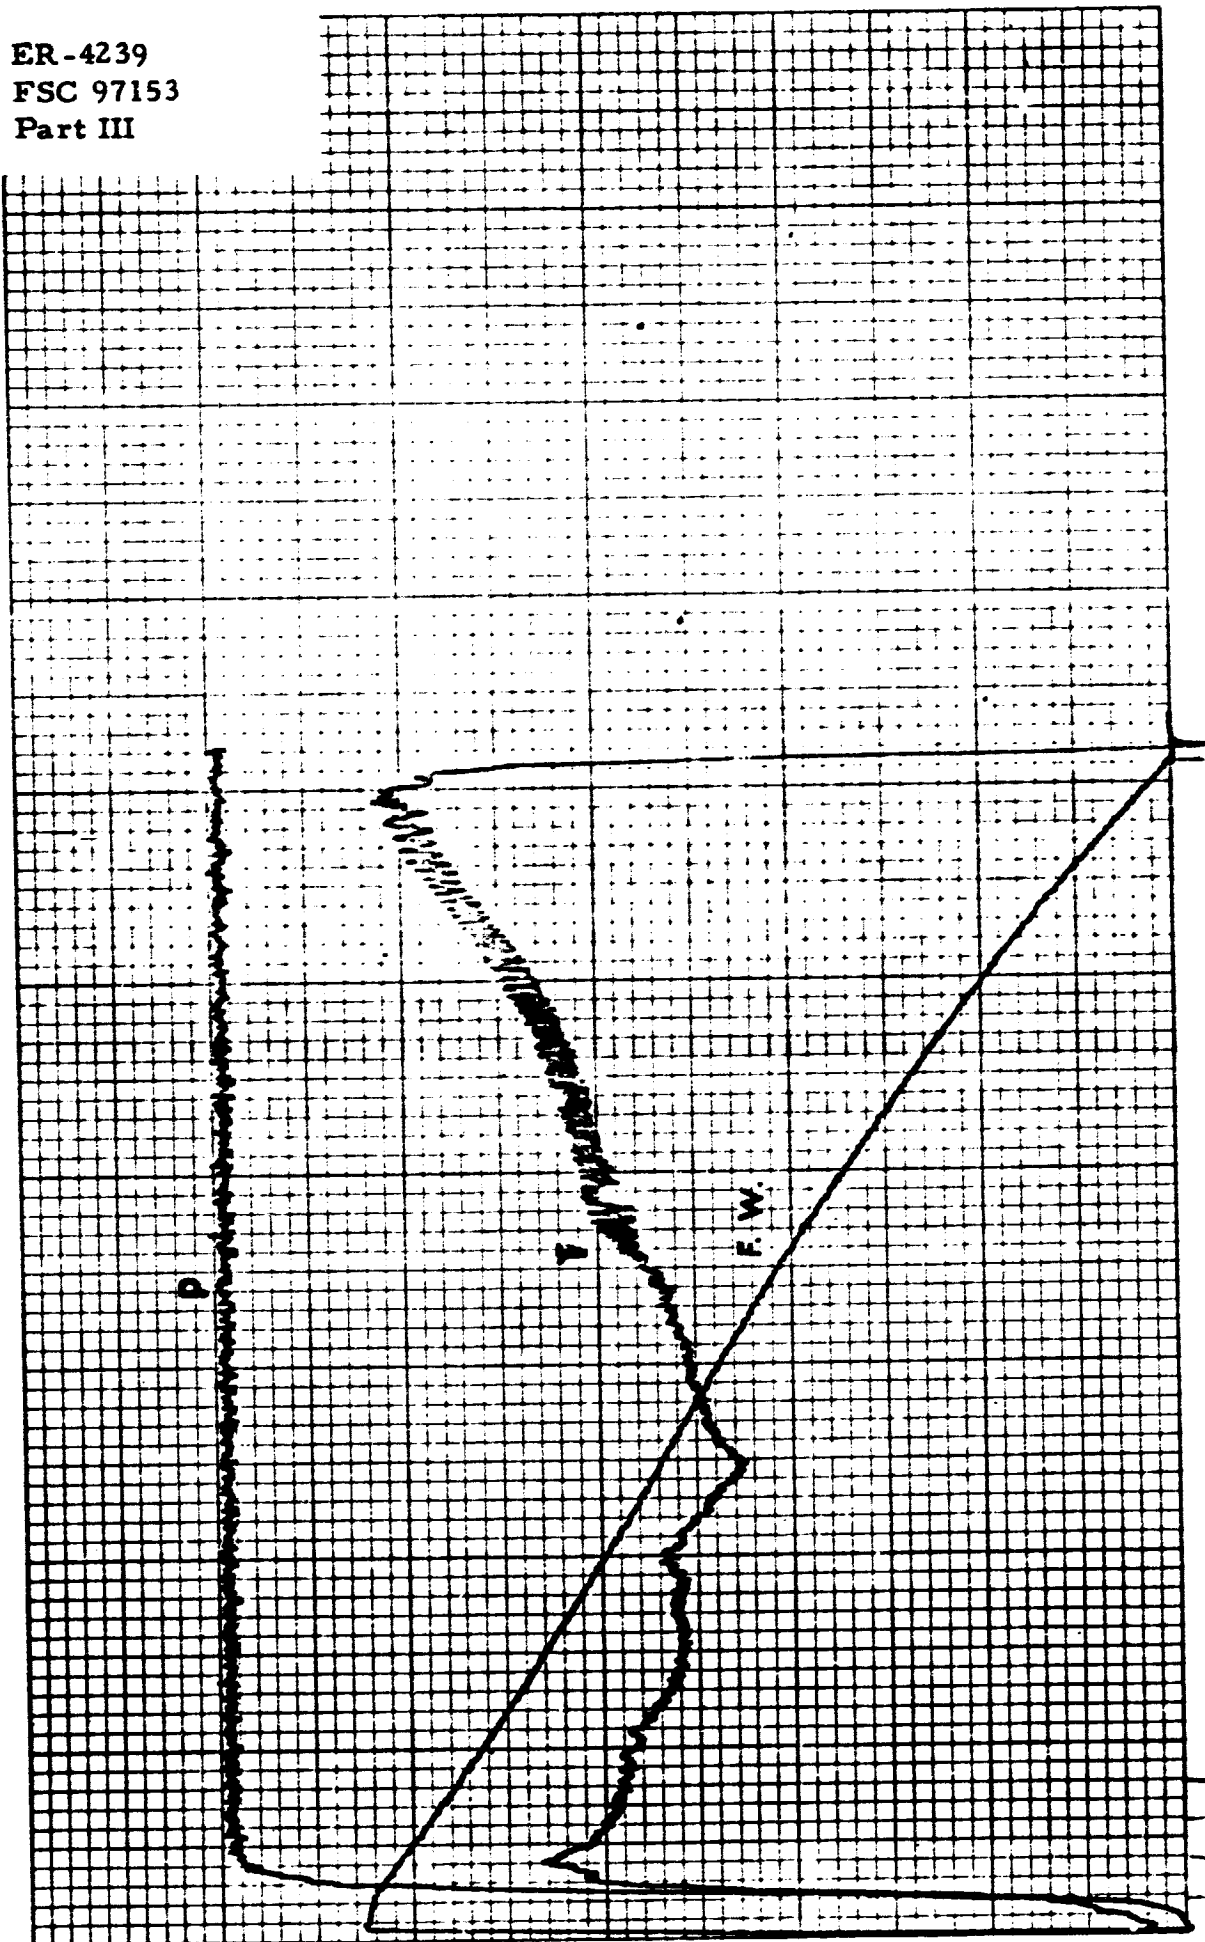
GRAPH NO. 11

The frictional characteristics of the heat sink were good with a coefficient of friction of approximately 0.21 as shown by pressure torque relationship on Graph No. 11.

TEST NO. 4027 SPEED 2096 PRESS/IN 100 PSI T.W./IN TEMP/IN
 RUN NO. 3 STOP TIME 29.8 TORQUE/IN 500 71-ABS μ /IN
 DATE 5-14-73 DISTANCE 546.4 R.W./IN 500 RPM F_B /IN TIME/IN 5.56G.

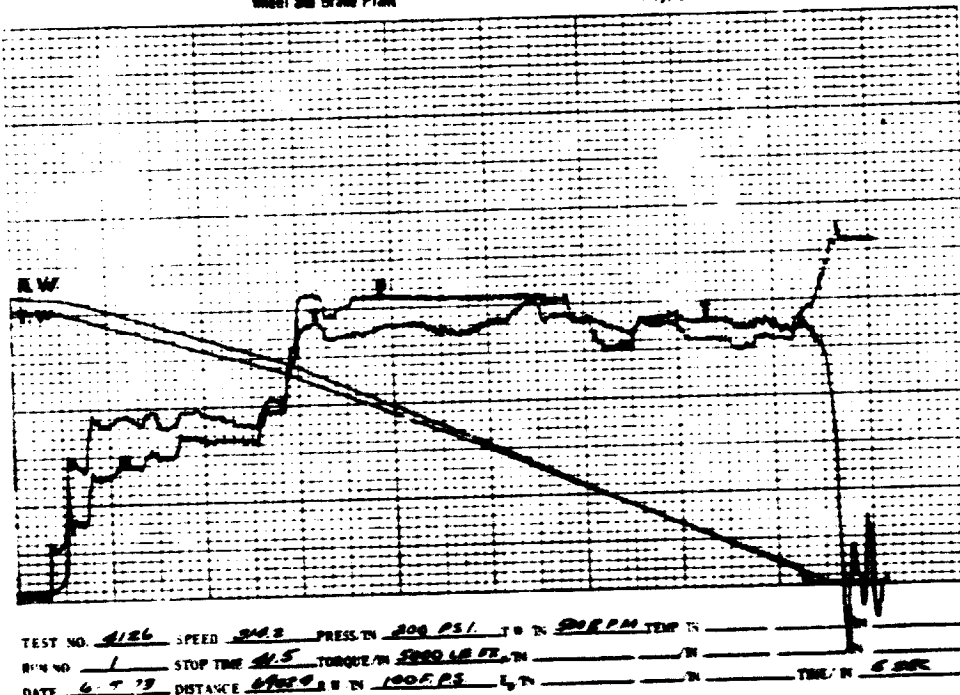
GRAPH NO. 12
Carbon Lined Beryllium Normal Energy Stop
Torque, Pressure VS Stop Time

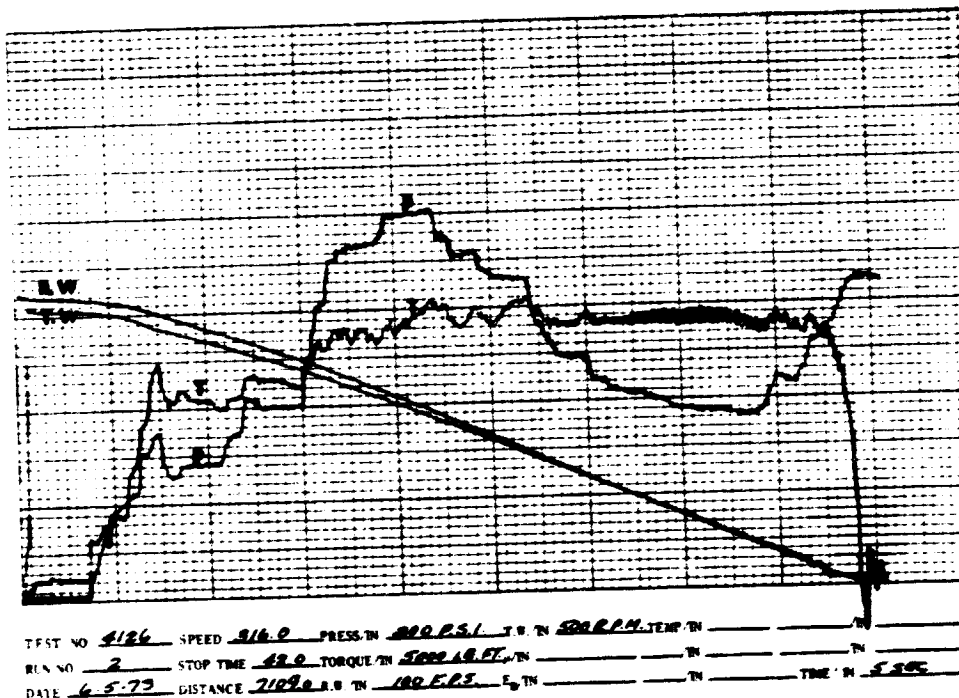
GRAPH NO. 13
Carbon Lined Beryllium Normal Energy Stop
Torque, Pressure VS Stop Time

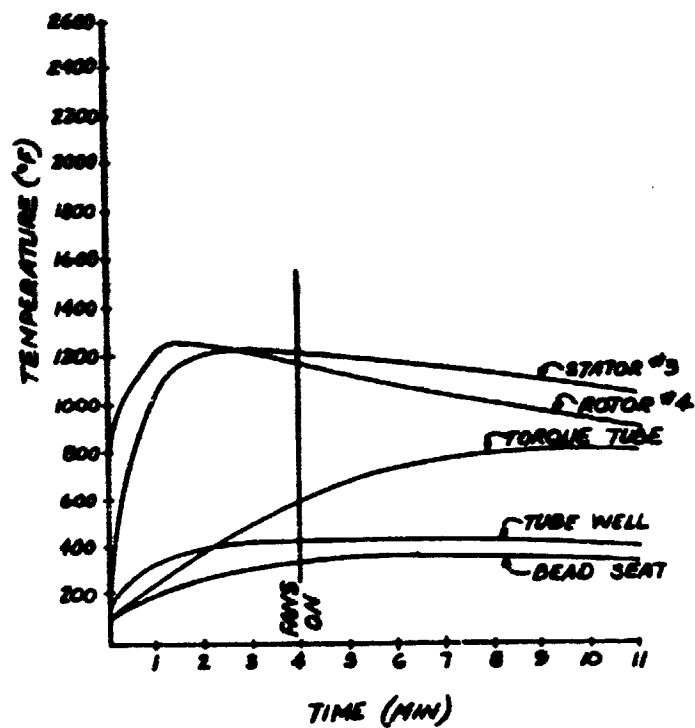
GRAPH NO. 14

TEMPERATURE SURVEY
CARBON LINED BERYLLIUM BRAKE
KE = 42×10^6 FT-16s

Graph No. 1 shows the results of the temperature survey performed on the carbon lined beryllium brake for the five stop requirement. The wheel temperatures were approaching their limit with a brake heat sink temperature of 1200°F. The addition of the wheel heat shields will lower these temperatures to a safe level, but would not maintain these levels for an equivalent weight structural carbon brake that operates at 2000°F.

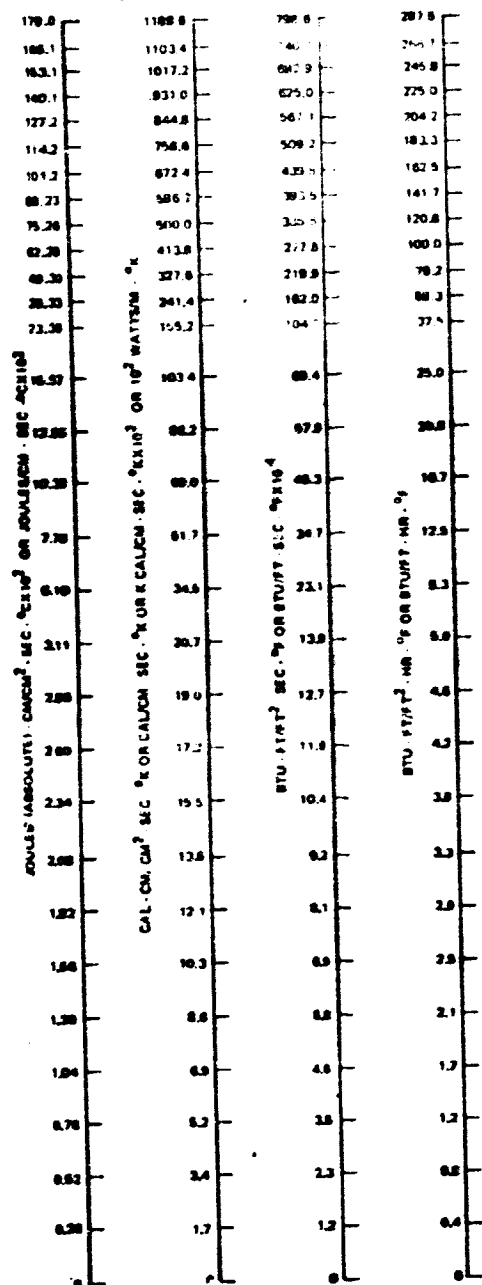
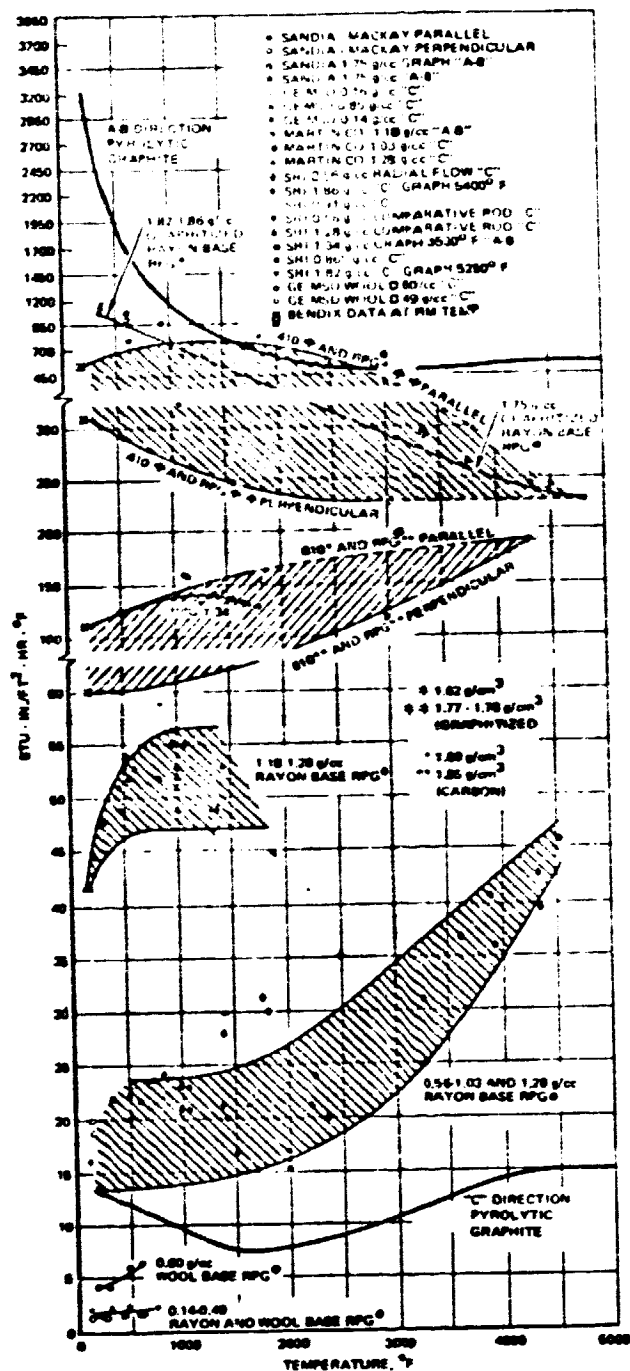
Thermal conductivity of carbon felt/CVD carbon and "graphite" cloth/CVD carbon composites as a function of temperature and density tested in the indicated direction

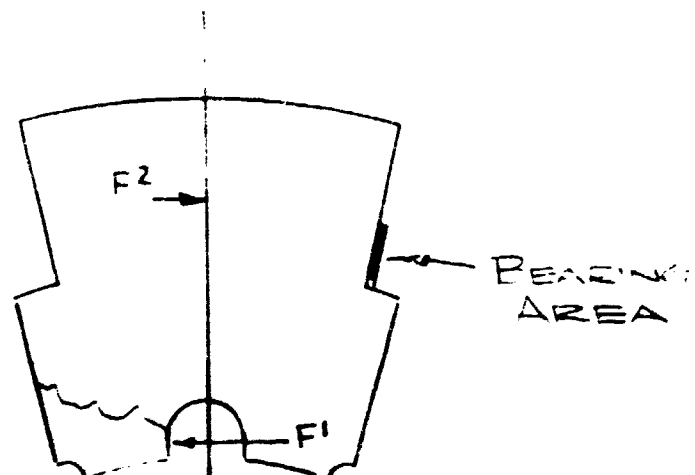
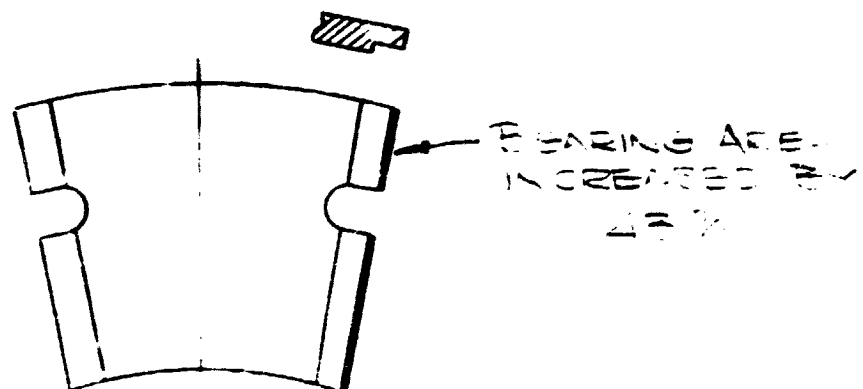
The method of attaching the lining segment can be revised to minimize the problems caused by lining warpage. Photograph 17 and Figure 9 show the method of attachment of the lining segments for the stator and back plate. The backplate attachment holds the edges of the lining segment down while the stator attachment allows the segment to curl. The backplate attachment was a proven but heavier design and was used only for attachment of lining to the backplate. The advantages of the backplate attachment design now justified the increase in weight and should be used for attaching the lining to the rotors and stators as shown by Fig. 10.

PRESENT DESIGN

BACKPLATE DESIGN

STRESS ANALYSIS IN STATOR
LINE 1 - SEGMENT

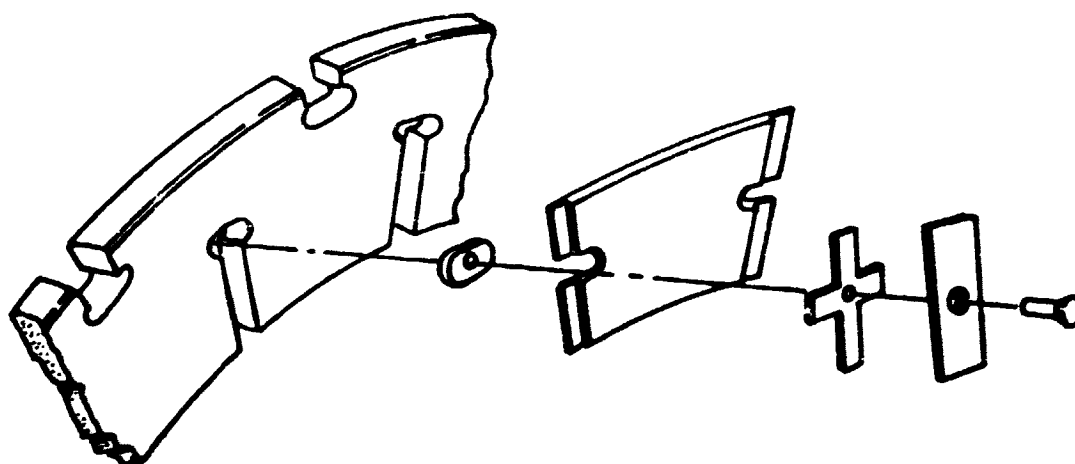
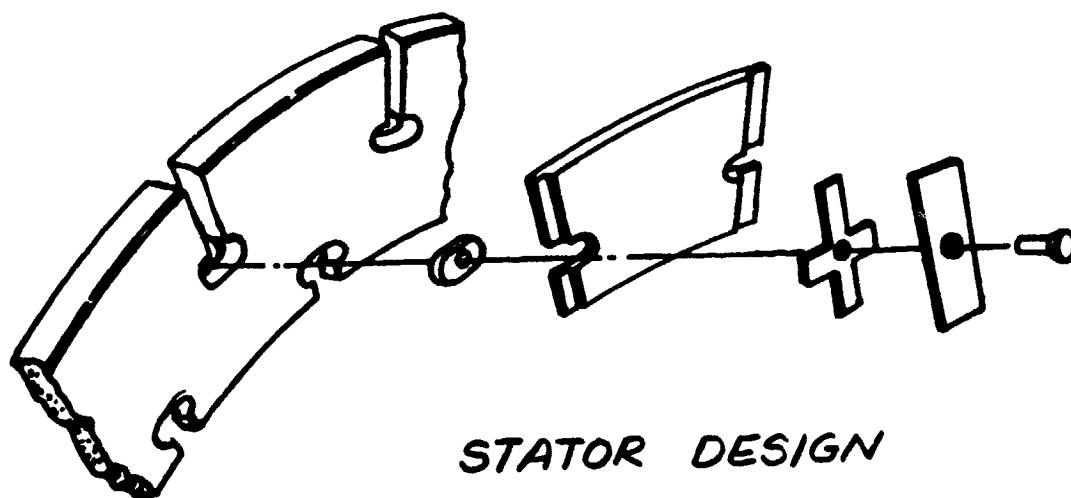
ROTOR DESIGN

STATOR DESIGN

Figure 10
Proposed Rotor and Stator Lining Attachment

1. The thermal conductivity and high temperature stability of the lining segment must be increased to eliminate the melting of the steel lining attachment and warpage of the lining segment.
2. The method of attaching the lining to the rotor and stators should be changed to the method used on the back plate. The back plate design increases the bearing area and retains the edges of the lining segment, minimizing the problems caused by lining warpage.

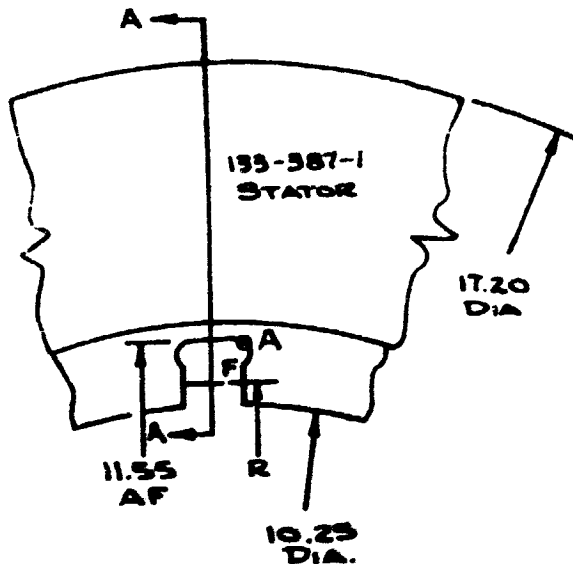
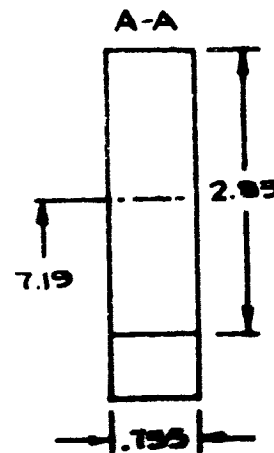
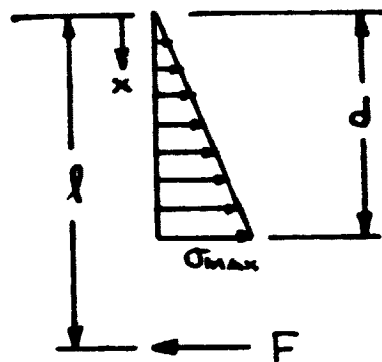
Theoretical Mechanical Stress Analysis of 133-387-1 Stator

$$F = \text{Force on Lug} = 12T/NnR = 281.4 \text{ lbs}$$

Assumed Loading Conditions

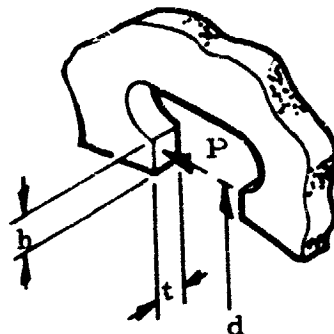
C-5A

t = .42 in
h = .38 in
d = 10.5 in
N_s = no. of slots = 11
N = no. of stators = 4

$$\text{Stress} = P / t h = \underline{8590 \text{ psi}}$$

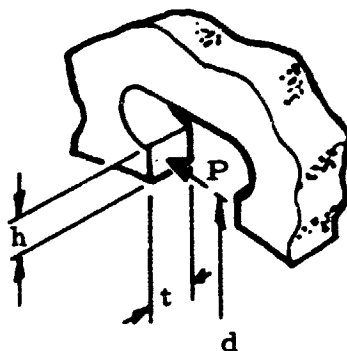
NASA

t = .575 in
h = .38 in
d = 10.5 in
N_s = 11
N = 5

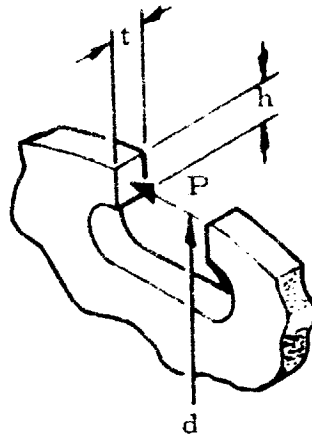
C-5A

$t = .37$ in
 $h = .35$ in
 $d = 18.0$ in
 $N_r = \text{no. of slots} = 9$
 $N = \text{no. of rotors} = 4$

$$\text{Stress} = P / t h = \underline{7540 \text{ psi}}$$

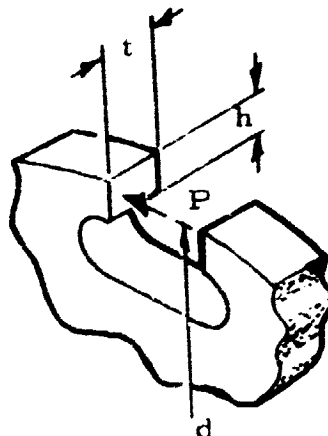
NASA

$t = .54$ in
 $h = .35$ in
 $d = 18.0$ in
 $N_e = 9$
 $N = 5$
